It might be the Shaft

Worn distributor bushings shouldn't be neglected

By Bruce Smith

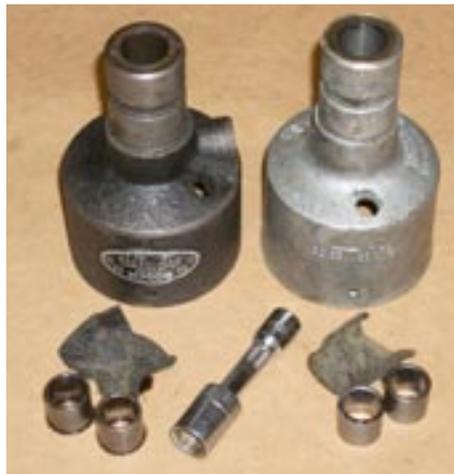
Right: Bosch cast iron 022 and aluminum body 031 distributors with factory shaft bushings. Bushings are removed with a shop press and a small socket and extender.

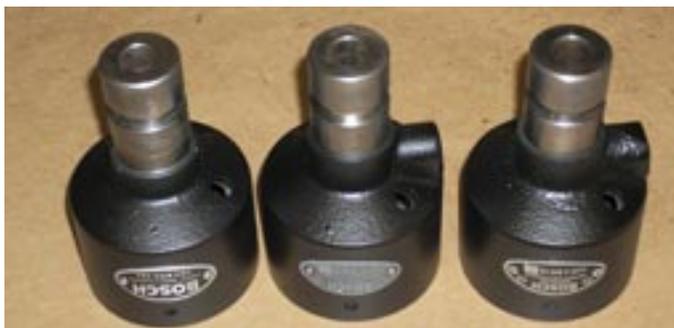
Below: Bosch cast iron BRS 383, BR9, and BR18 distributors with no factory shaft bushings.

But what to do if you're starting with a distributor that had no bushings to begin with, like the BRS383, BR9, or BR18 (or other older Bosch distributors)? In this case, the distributor body needs to be bored open to the correct dimension to accept the new bushings. Not too difficult a task, or to have your local machinist carry out. As shown below, after drilling the

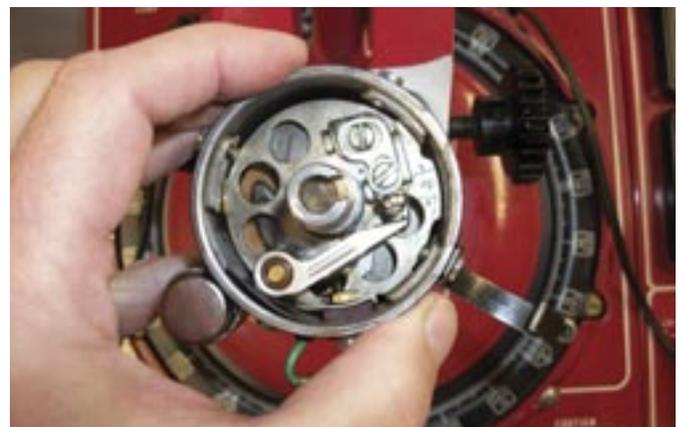
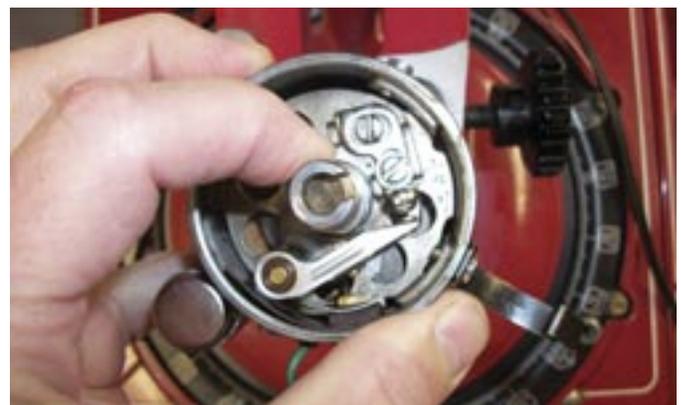
Pictured below is an example with a very worn out distributor. These side-by-side photos show the opening gap in breaker points when this distributor's shaft is at rest (left) compared to the gap when thumb pressure is applied to the top cam (right). The gap difference should normally be well below 0.1mm but here it is more than three times that.

A simple test for shaft play is to push on the cam and observe any change to the points gap. Here it's much larger than it should be.

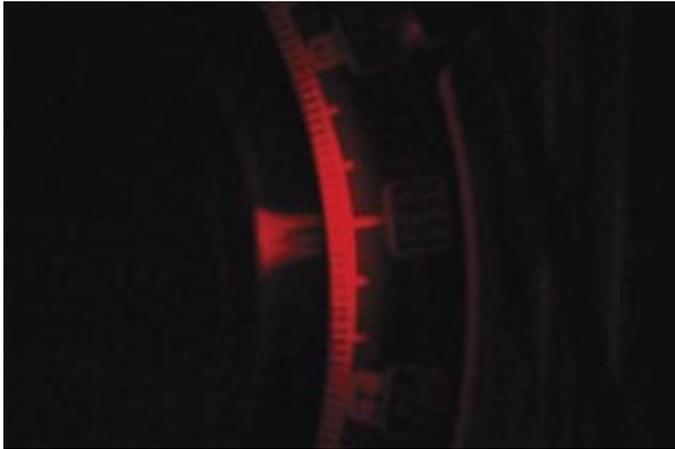
As you would expect, this distributor's dwell will wander significantly, especially at crank speeds above 3000 RPM. Spark delivery becomes erratic as well, leading to the firing between cylinders off by several degrees. The test results below show the extent of the problem. This is a 'lights-off' photograph from a Sun tester running this distributor at about 1500 RPM (3000 at the crank). The indicator needle on the left should point to a sin-

gle gradation marking. Instead, it jumps over a range of about 3°, which is a full 6° at the crank. It's not tough to imagine how this would impact a running motor. This was a distributor that had been 'rebuilt' with all of the standard kit parts and a new lick of paint. But the simple testing of the shaft play was evidently never done.

Excessive radial play will lead to erratic timing between rotations.
